January 22, 1998

Reference: EPA Contract No. 68-W4-0006; Work Assignment No. R05020; Daelyte Service Company/Astro Maintenance; Detroit, Michigan; EPA ID No. MID006537336; Site Inspection Trip Report; Task 06 Deliverable

**DAELYTE SERVICE COMPANY/ASTRO MAINTENANCE  
EPA ID No. MID006537336**

**SITE INSPECTION TRIP REPORT**

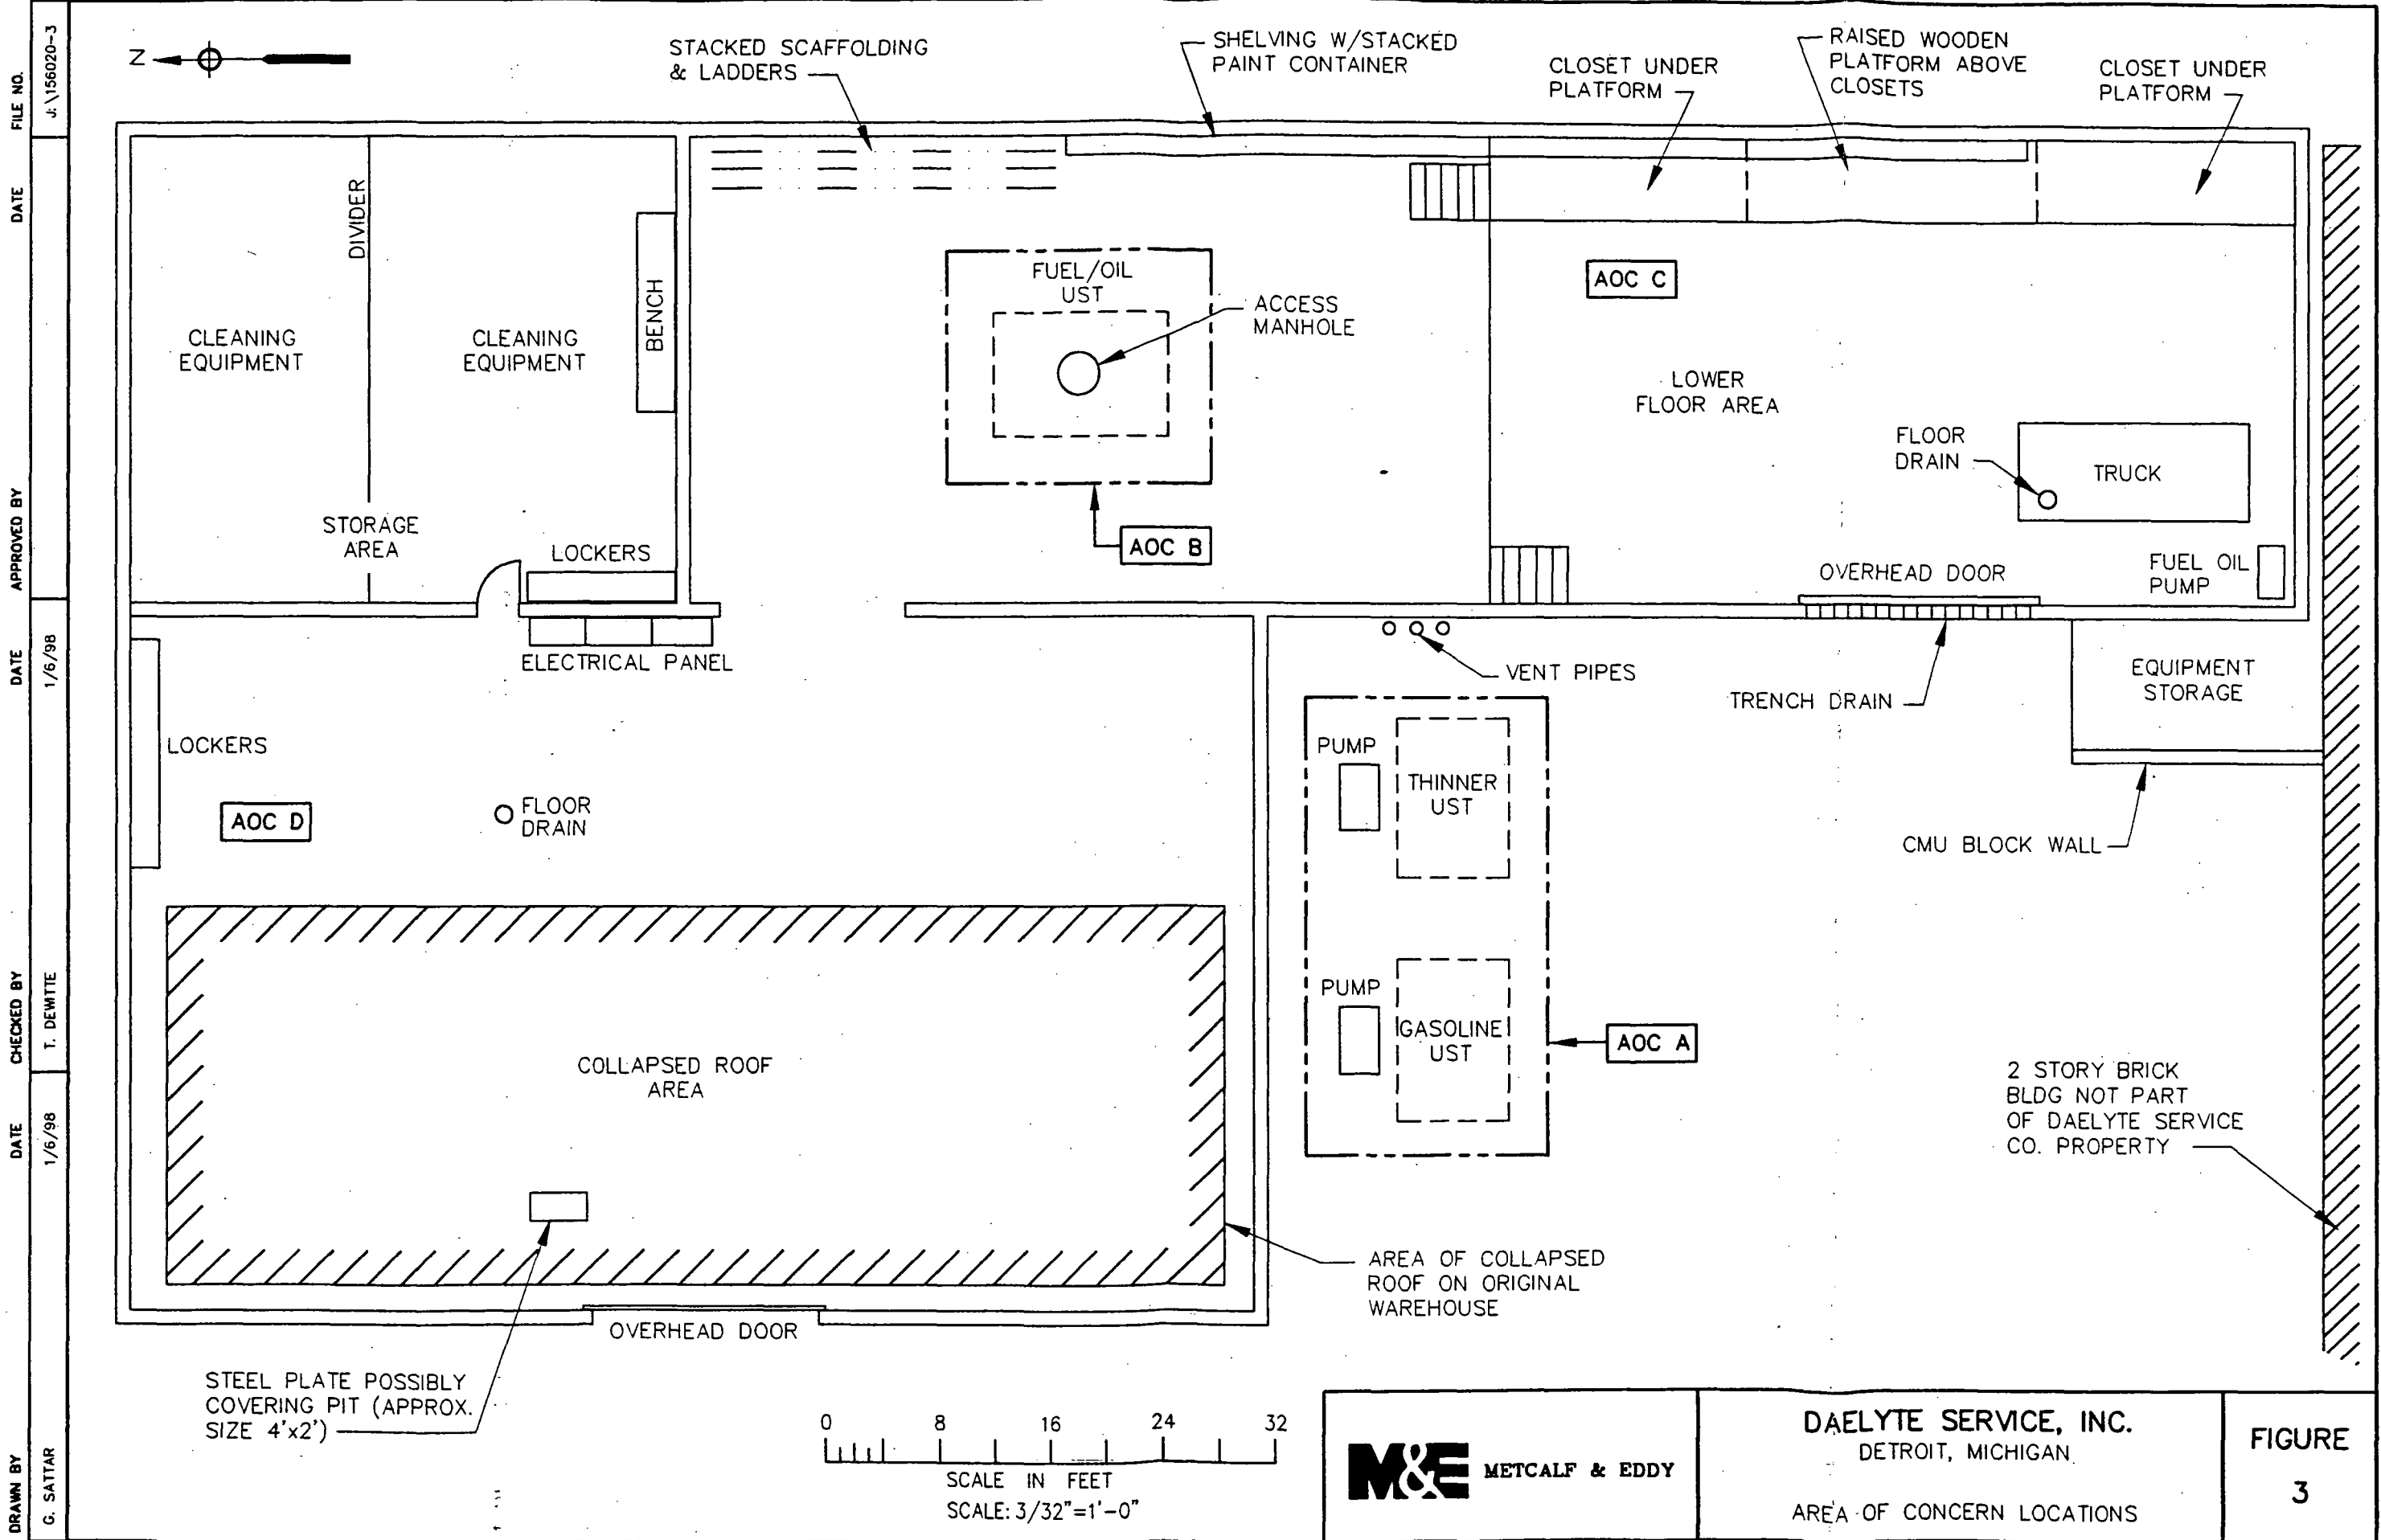
FIGURE  
3

This section presents descriptions of the Areas Of Concern (AOCs) identified during the SI at the Daelyte facility. The locations of the AOCs are identified in Figure 3. Photograph numbers correspond to those presented in the Photograph Log in Appendix A.

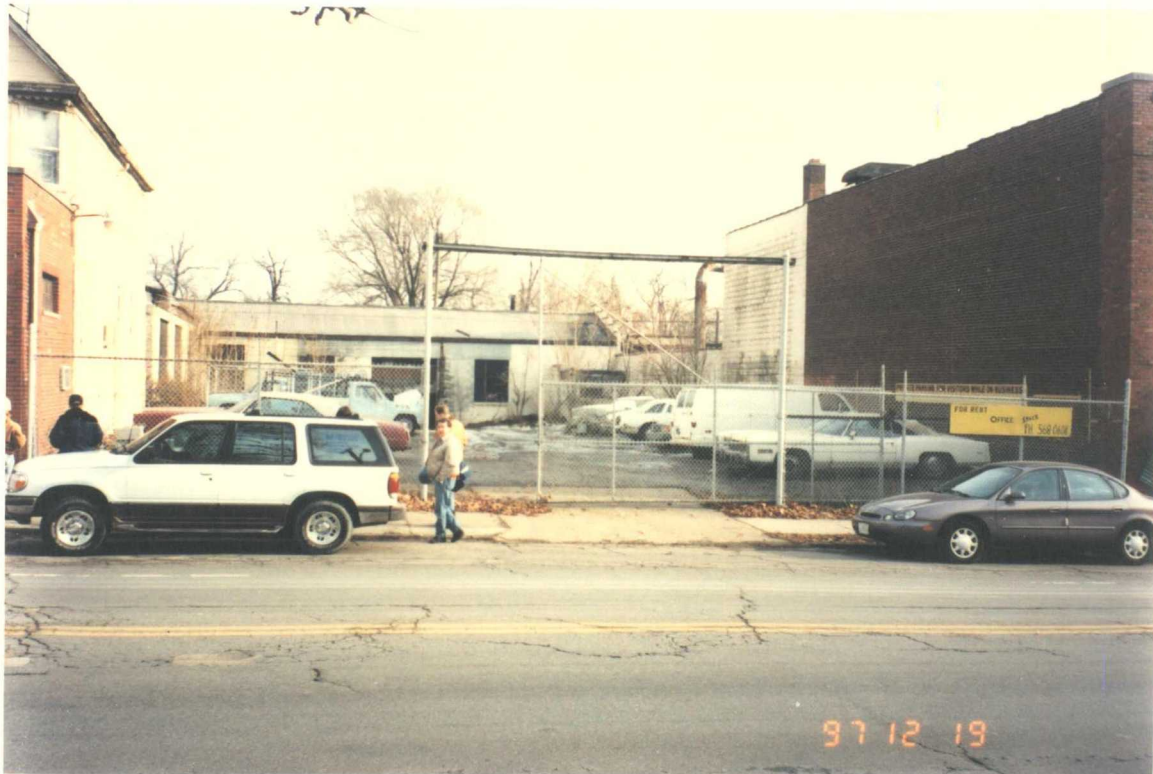
Photo No.: 1-1  
Date: 12/19/97

Description: Daelyte facility parking area viewed from across Mt. Elliott Road.

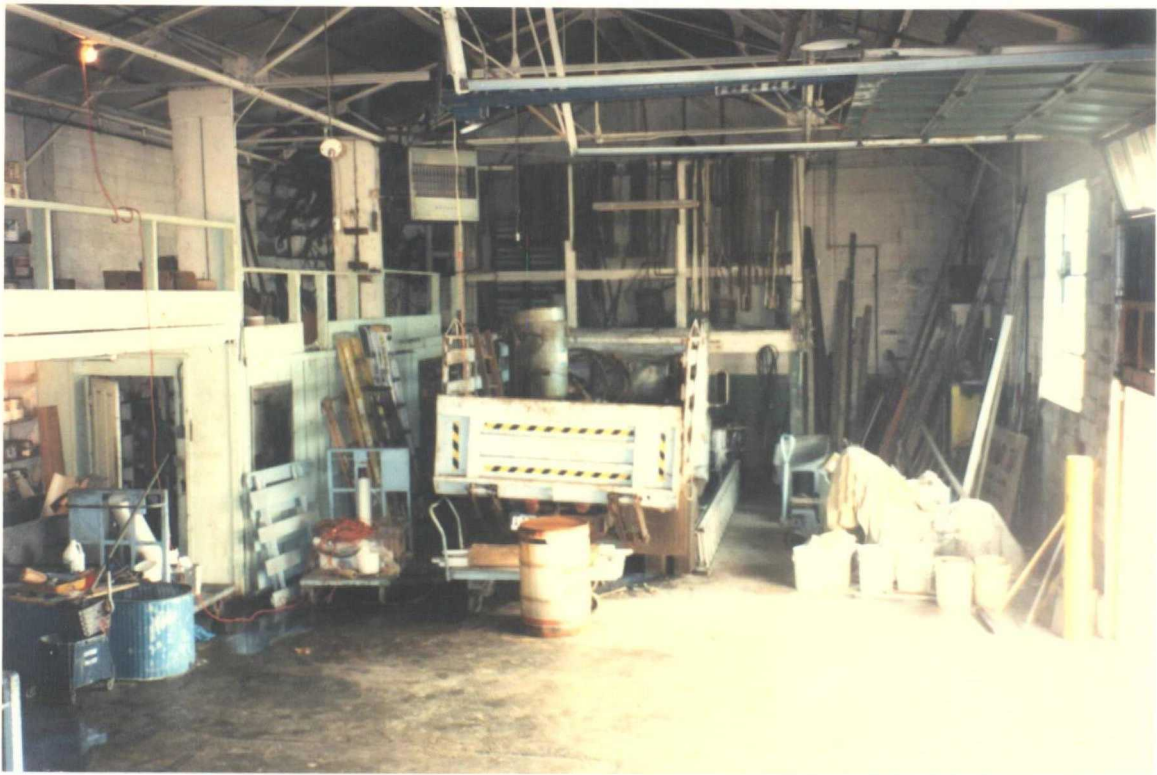
Photo No.: 1-5

Description: Southern portion of the east addition of the Daelyte warehouse. The garage door used for entry into the warehouse is the source of light at the far right edge of the photograph.

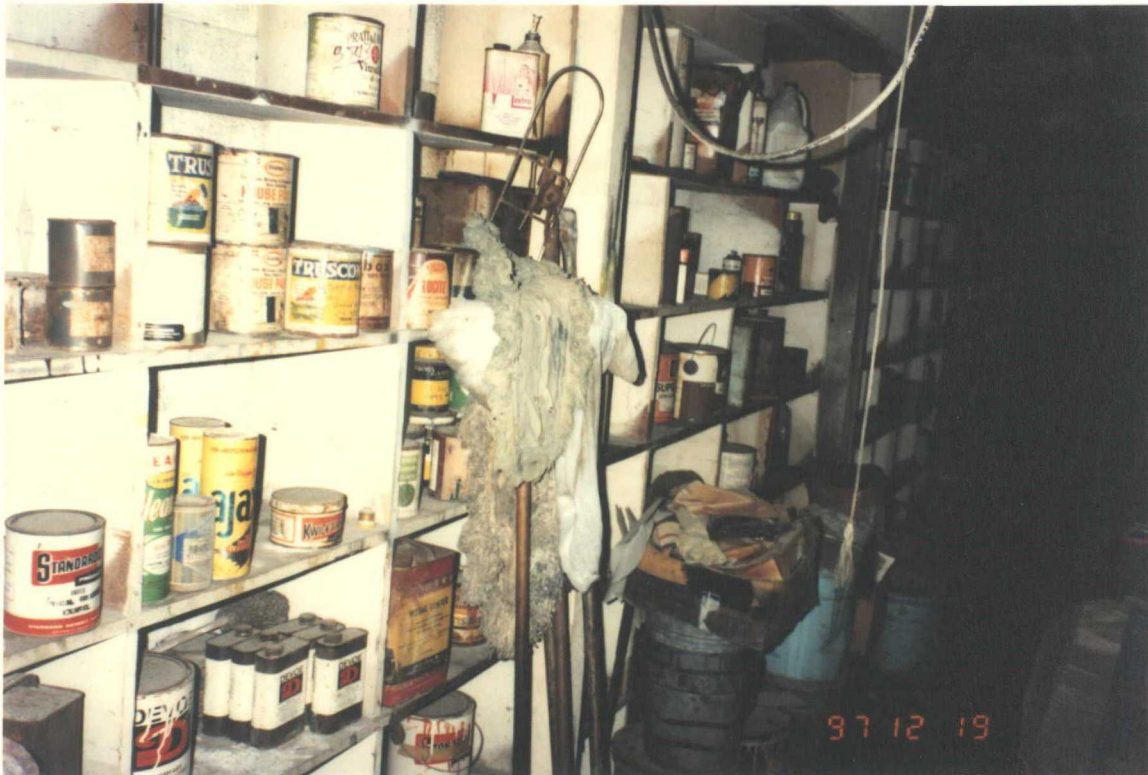
Photo No.: 1-6  
Date: 12/19/97

Description: Southern walk-in closet in south portion of east addition.

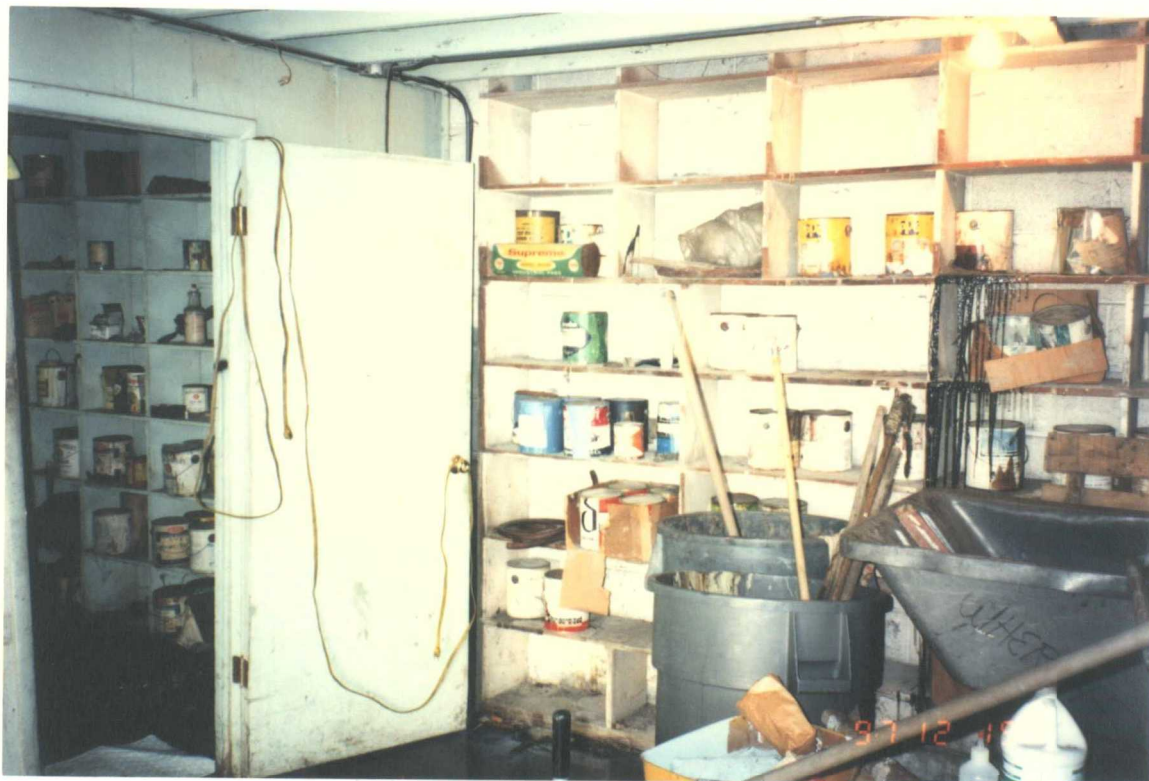
Photo No.: 1-7

Description: Northern walk-in closet at south end of east addition may be seen on the left side of the photograph. Container storage may be seen on the shelves.

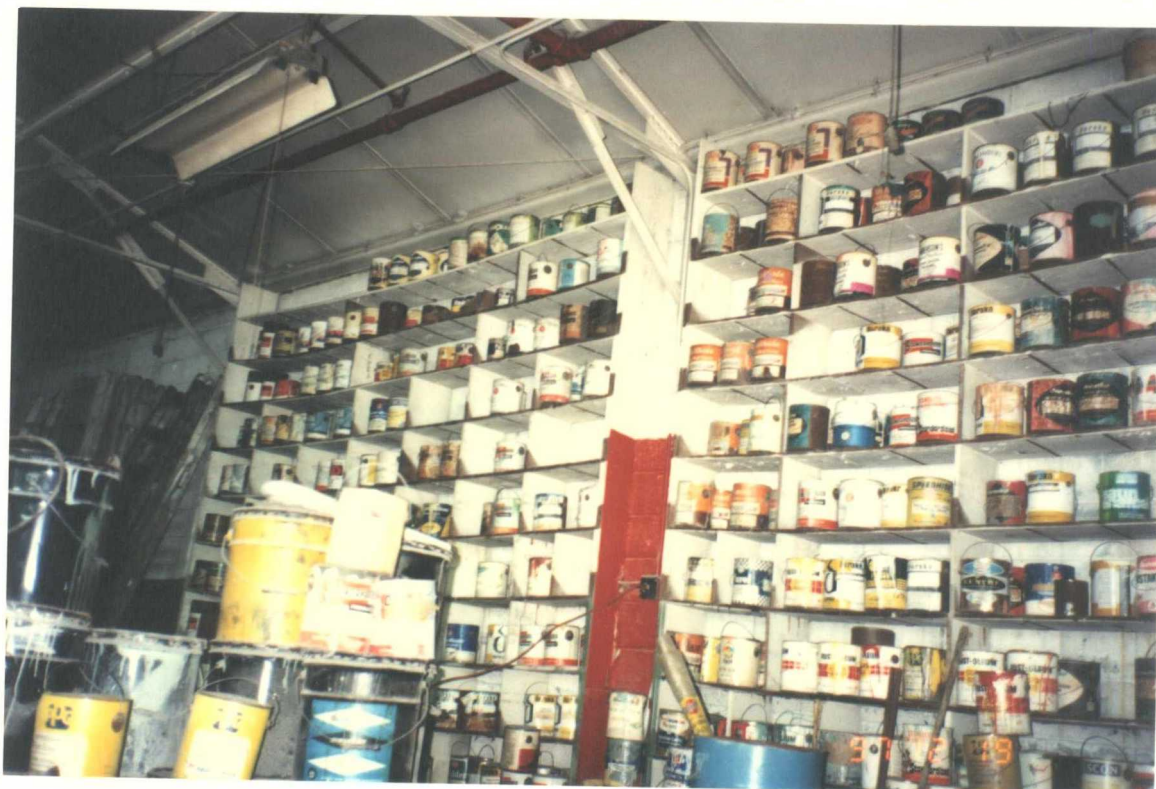
Photo No.: 1-11  
Date: 12/19/97

Description: East-central portion of the east addition facing northeast. This photograph shows the storage area above and behind that area shown in Photograph 1-10.
